Designated Substances Survey -Emily-Omemee Community Center –212 Sturgeon Road, Omemee, Ontario

December 10, 2024

Prepared for:
City of Kawartha Lakes

Cambium Reference: 21989-001

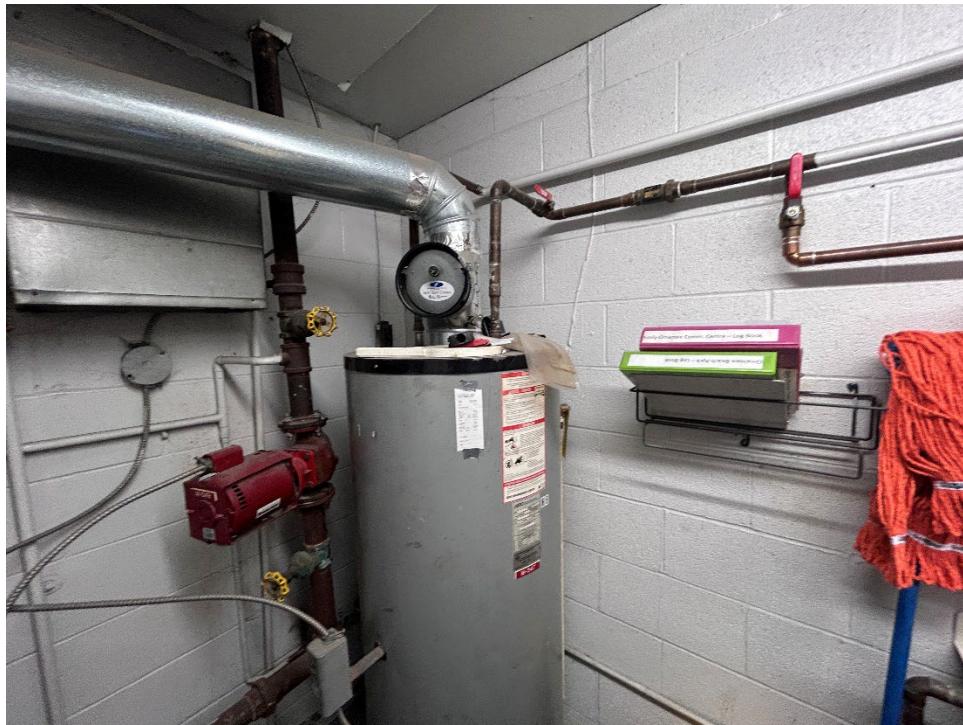
Mechanical equipment throughout the building was observed to be either uninsulated or insulated with non-asbestos fibreglass.

Photo 1 Fibreglass insulated mechanical equipment

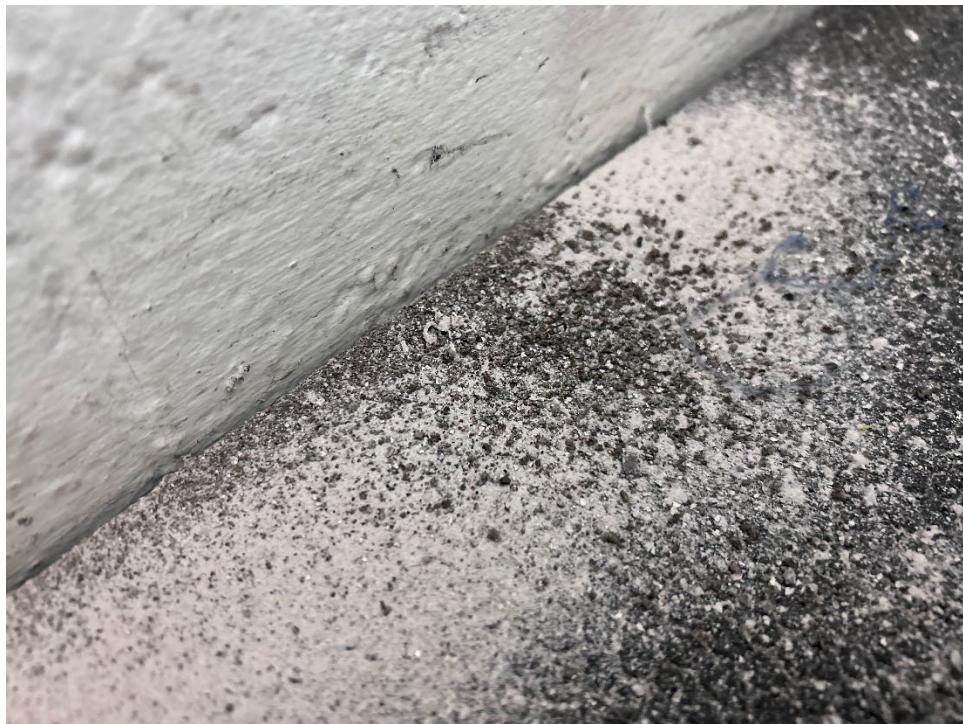
Non-asbestos vermiculite is present in the concrete block wall between the arena and main floor lobby area, and exterior walls of the building (samples ASB-114.1 to ASB-114.3).

Photo 2 Non-asbestos vermiculite.

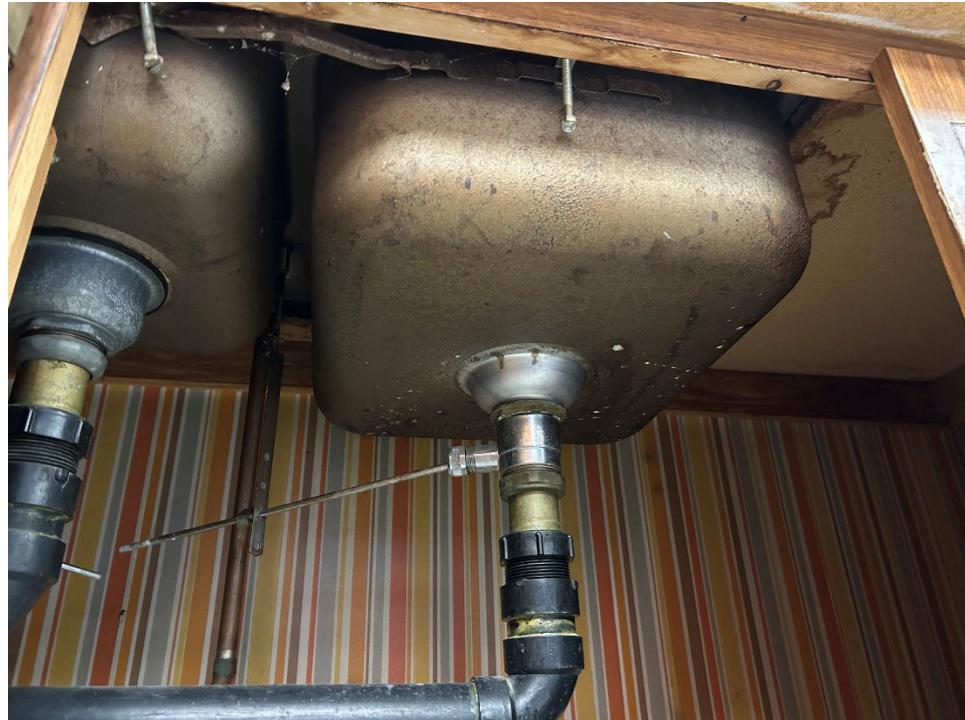
Brown sink coating, containing chrysotile asbestos, is present on the underside of four sinks in the kitchen on the second floor (sample ASB-102.1). There is approximately 4 square feet of asbestos-containing sink coating, and it was observed in good condition.

Photo 3 Asbestos-containing brown sink coating

- Brown sink coating, containing chrysotile asbestos, is present on the underside of the sinks in the kitchen on the second floor. If affected by planned renovation activities, remove brown sink coating using Type 1 procedures as outlined in O. Reg. 278/05.
- Grey caulking, containing chrysotile asbestos, is present on the north wall of the exterior of the building. If affected by planned renovation activities, remove grey caulking using Type 1 procedures as outlined in O. Reg. 278/05.

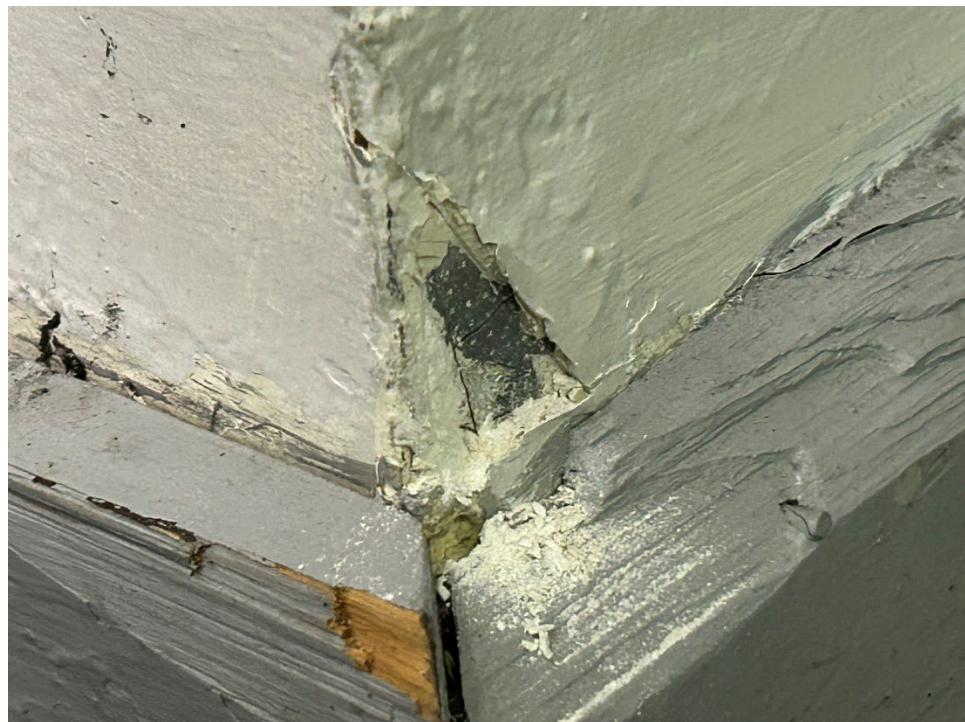
Non-asbestos drywall joint compound is present on gypsum wall and ceiling finishes in various areas throughout the building (samples ASB-105.1 to ASB-105.7).

Photo 4 Non-asbestos drywall joint compound.

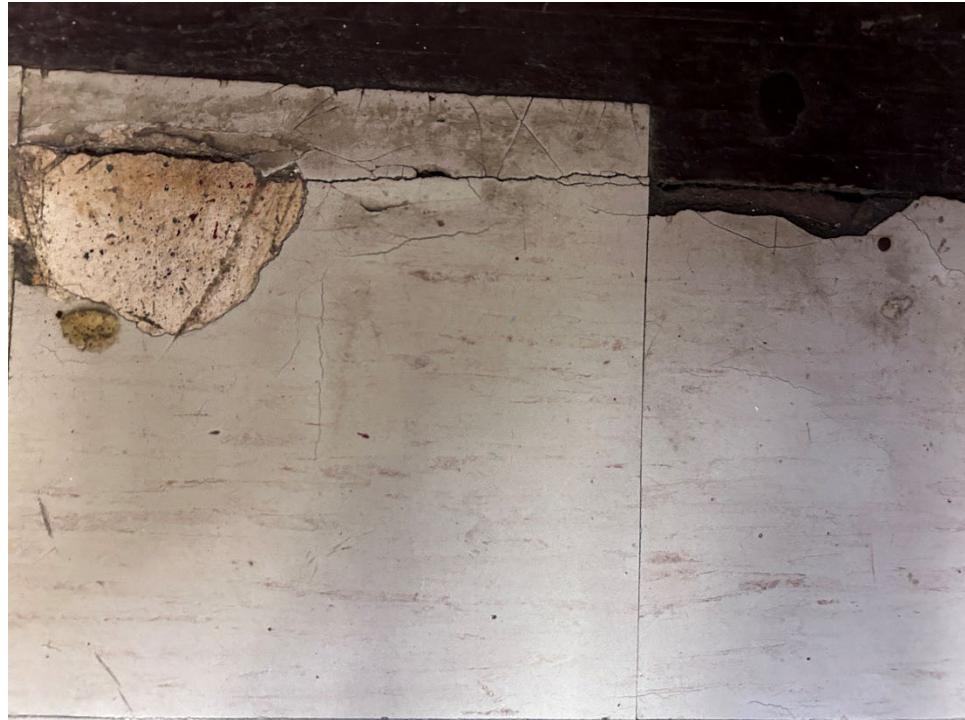
Photo 5 Non-asbestos 12" x 12" off-white vinyl floor tiles with faint burgundy streaks.

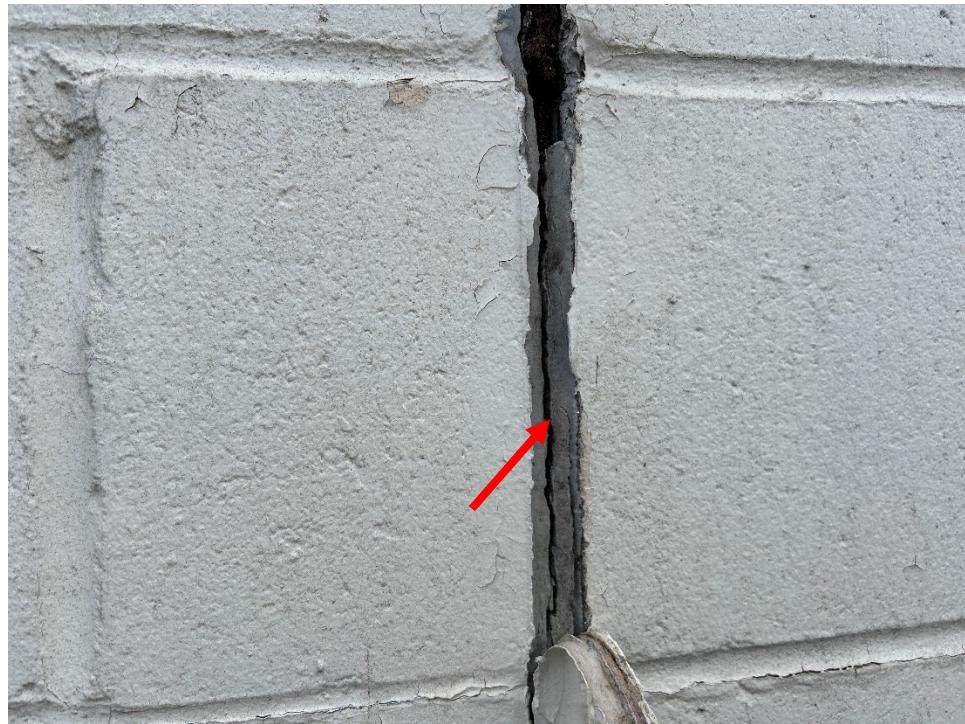
Asbestos-containing grey caulking was observed in good condition.

Photo 6 Asbestos-containing grey caulking.

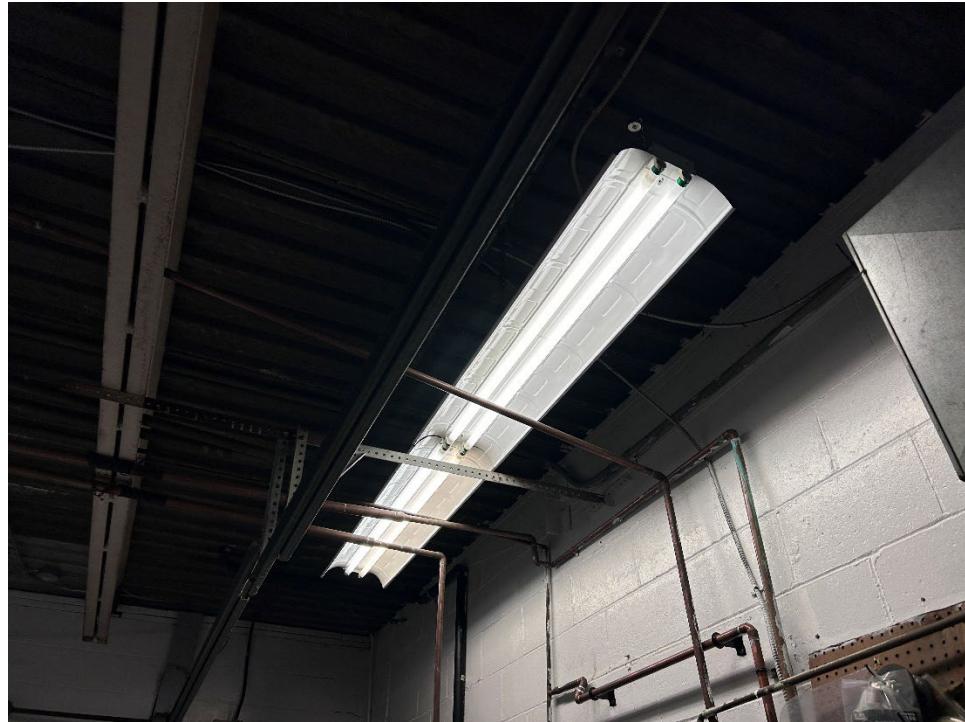
- Mercury is likely to be present as a liquid in thermostats and in minor quantities as a vapour within all fluorescent light tubes throughout the building.

Photo 7 Mercury containing fluorescent light ballasts.

- The presence of mercury within assembled units (e.g., fluorescent light bulbs) should not be considered a hazard provided that the assembled units remain sealed and intact. Avoid skin contact with mercury and avoid inhalation of mercury vapour. Dispose of mercury following applicable legislative requirements.
