| <b>Addendum</b> | 03 |
| <b>Project:</b> | KGCC - Clubhouse |
| <b>Address:</b> | 777 Clonsilla Av. Peterborough ON |

Kawartha Golf and Country Club  
777 Clonsilla Avenue  
Peterborough, Ontario

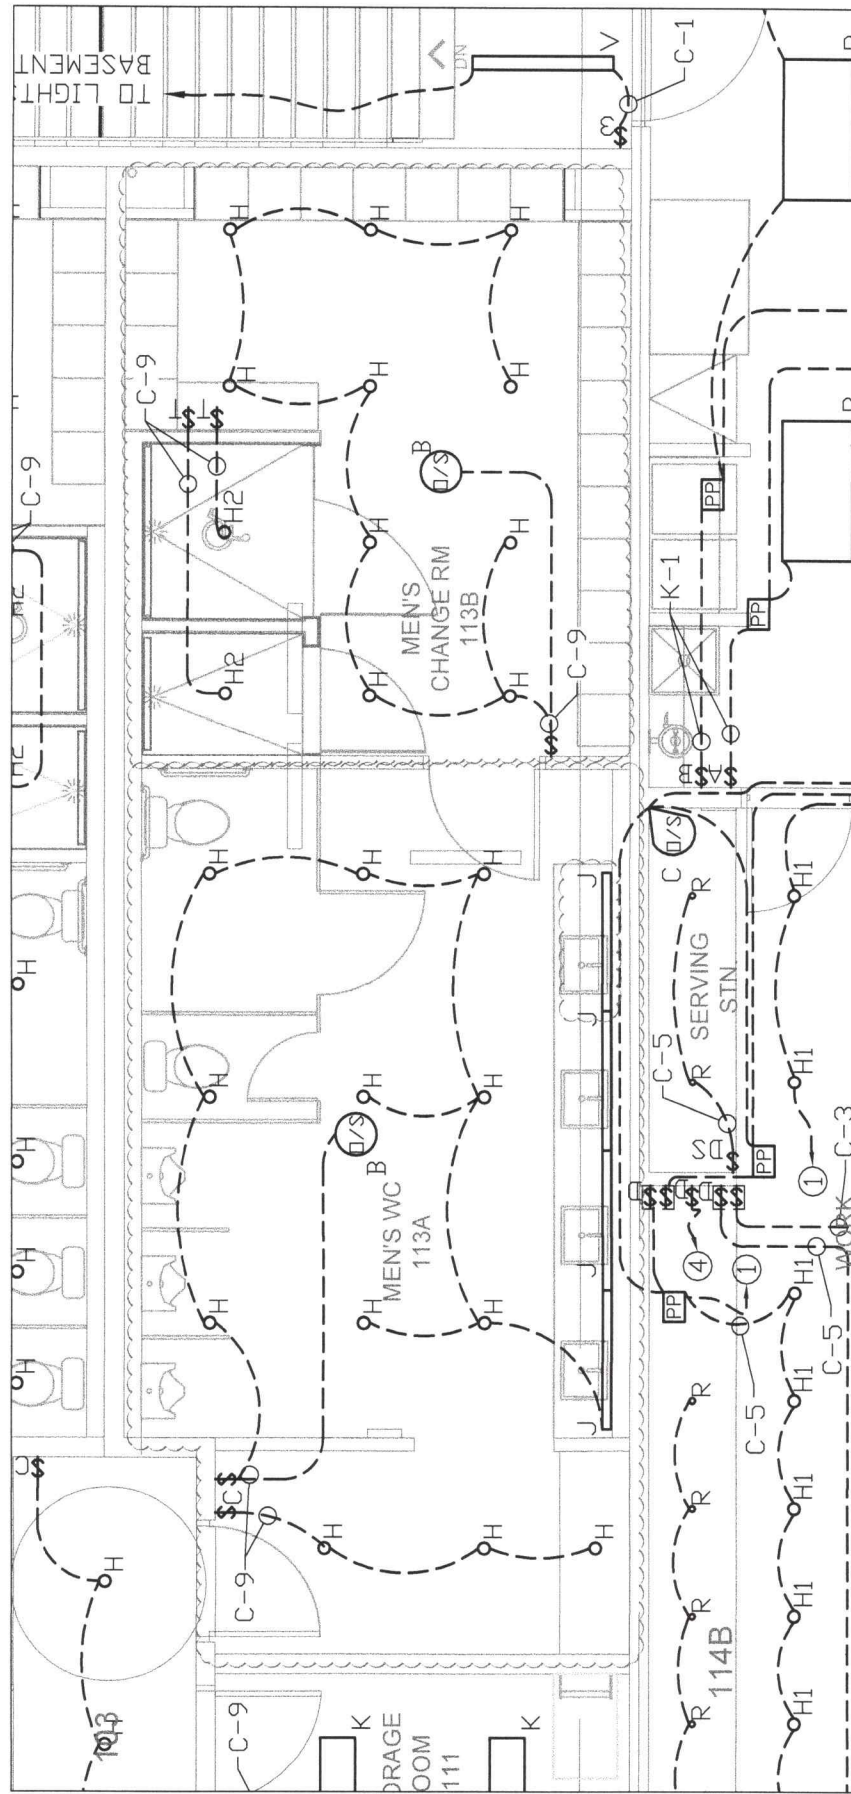
3. Lights in Men's Washroom 113A have been rearranged. See Sketch SK-E1.
4. Add one (1) new type 'J' fixture above the sink in Men's Washroom 113A. See Sketch SK-E1.

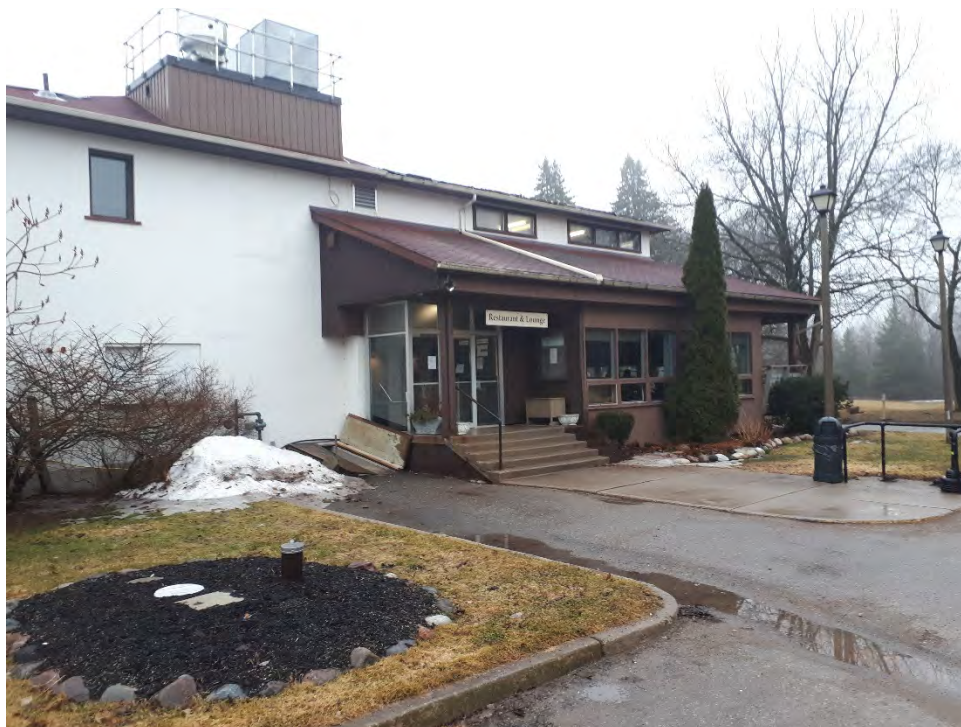
Photo 1 – View of existing Club House.

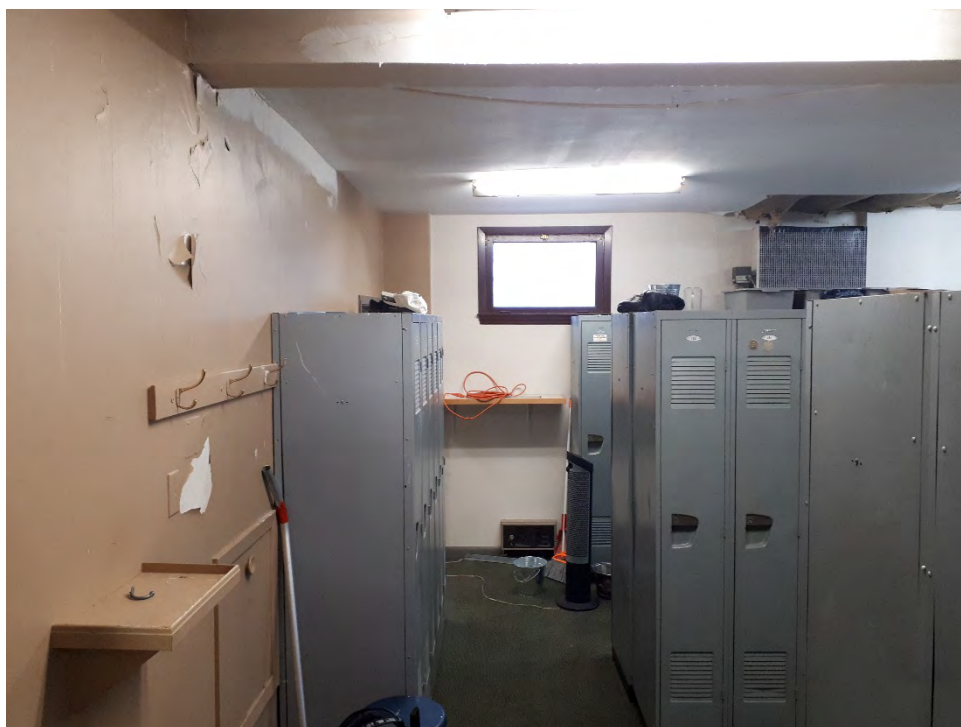
Photo 2 – 2<sup>nd</sup> floor men's change room in Club House. Air sampled for mould (AS-04).

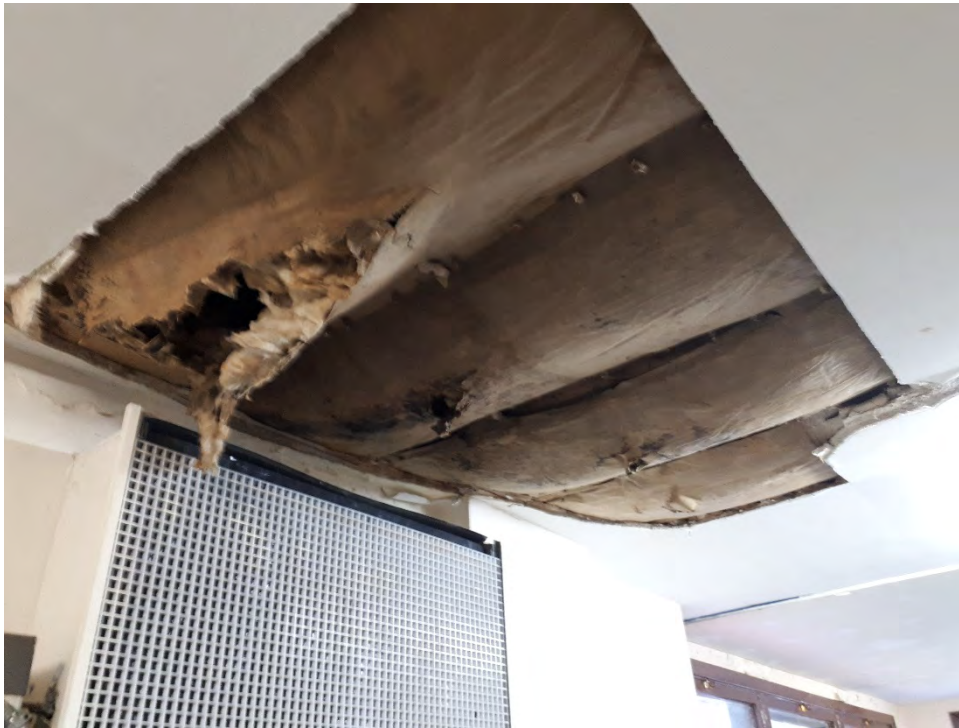
Based on visual observations, building materials were generally in fair condition, with peeling of paint, crumbling of plasters and water damage observed in some areas. Roof leaks were observed in the men's change room of the Club House, and the back room of the Pro Shop. Indications of mould were observed in the back room of the Pro Shop.

Photo 3 – View of water leak in men's change room.

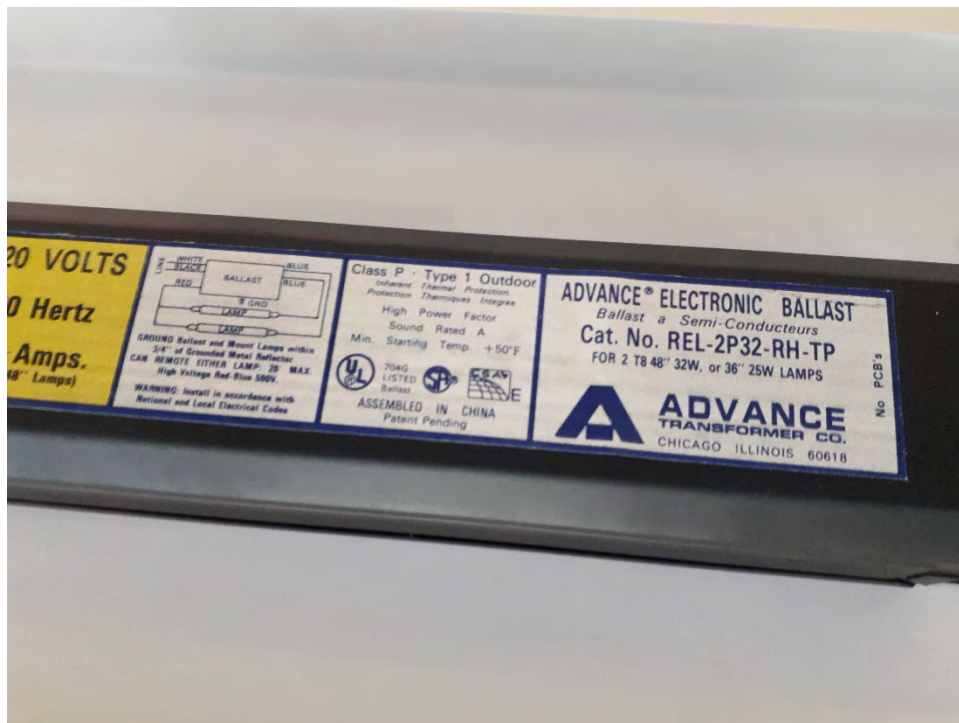
Photo 4 – Light ballast inspected from 2<sup>nd</sup> floor common room. No PCB's identified.

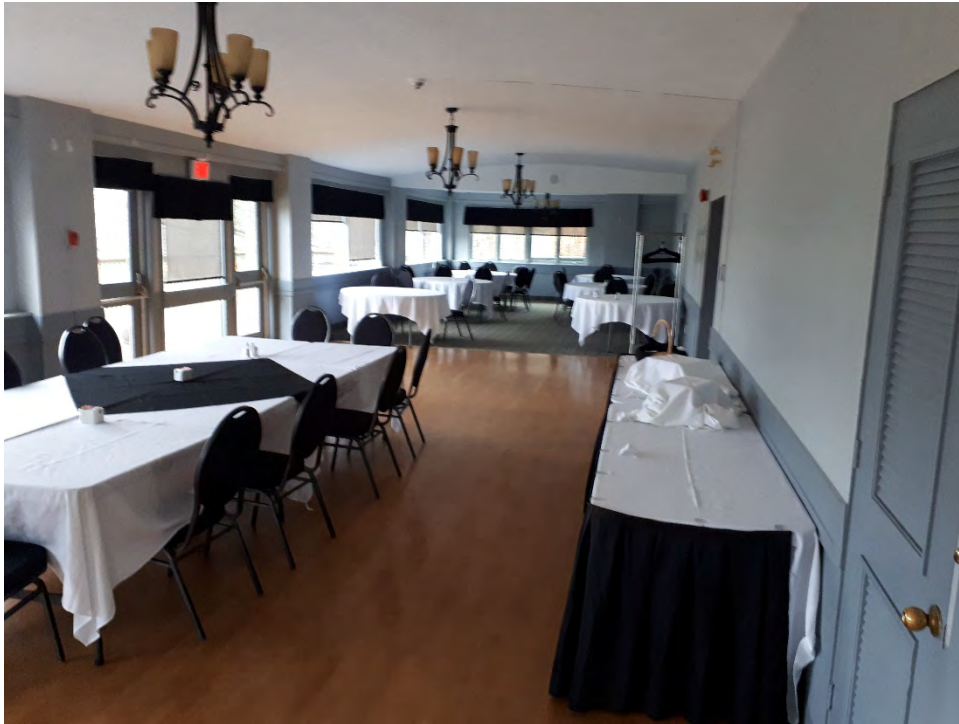
Photo 5 – Banquet hall in club house. Ceiling finishing material identified as asbestos containing.

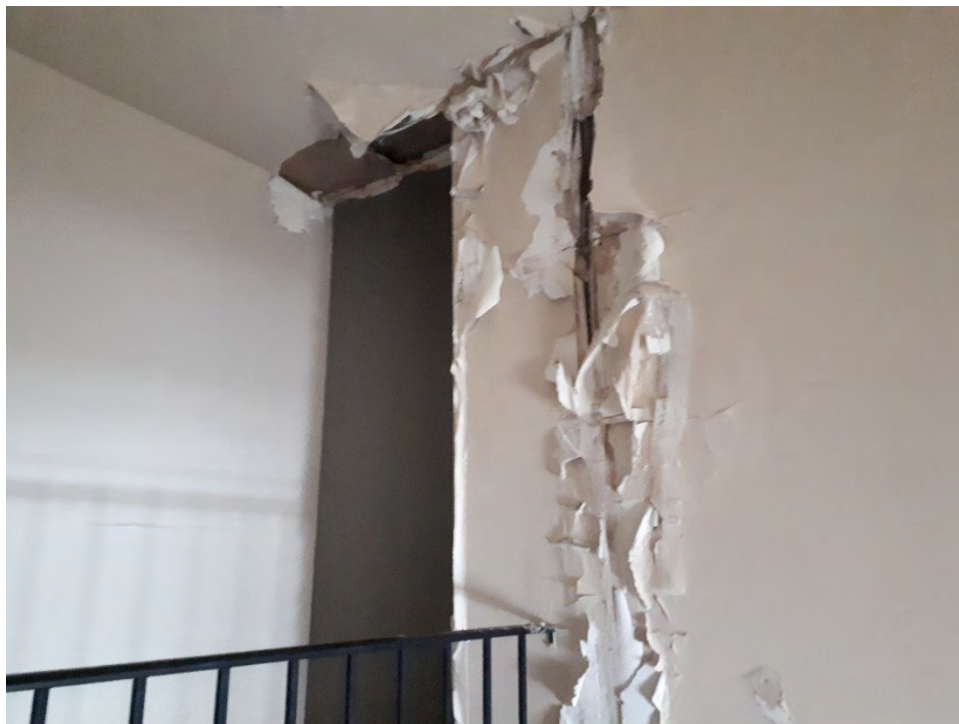
Photo 6 – Peeling of paints observed. Several paints tested were identified as lead based.

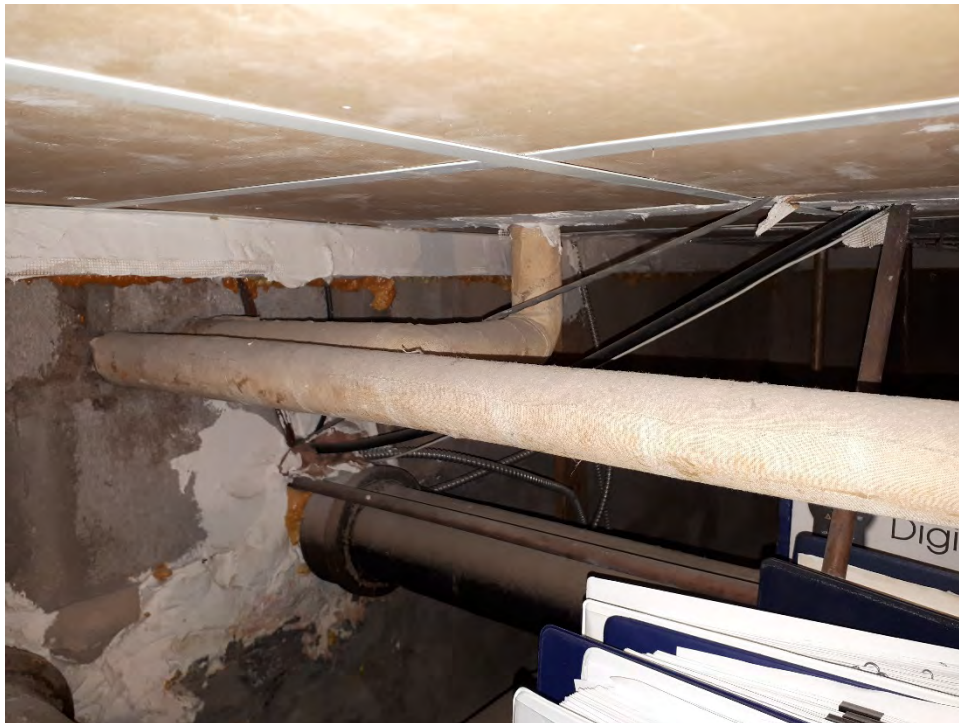
Photo 7 – Pipe insulation in the basement of the club house observed to be fiberglass.

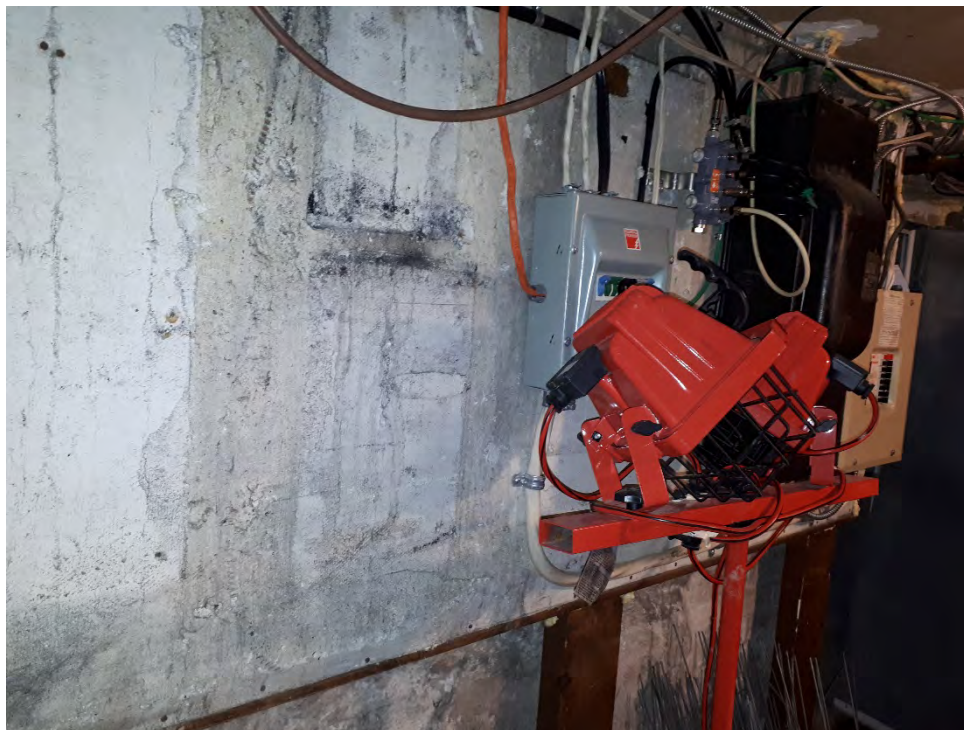
Photo 8 – Paper material on electrical panel in basement of the club house identified as asbestos containing.

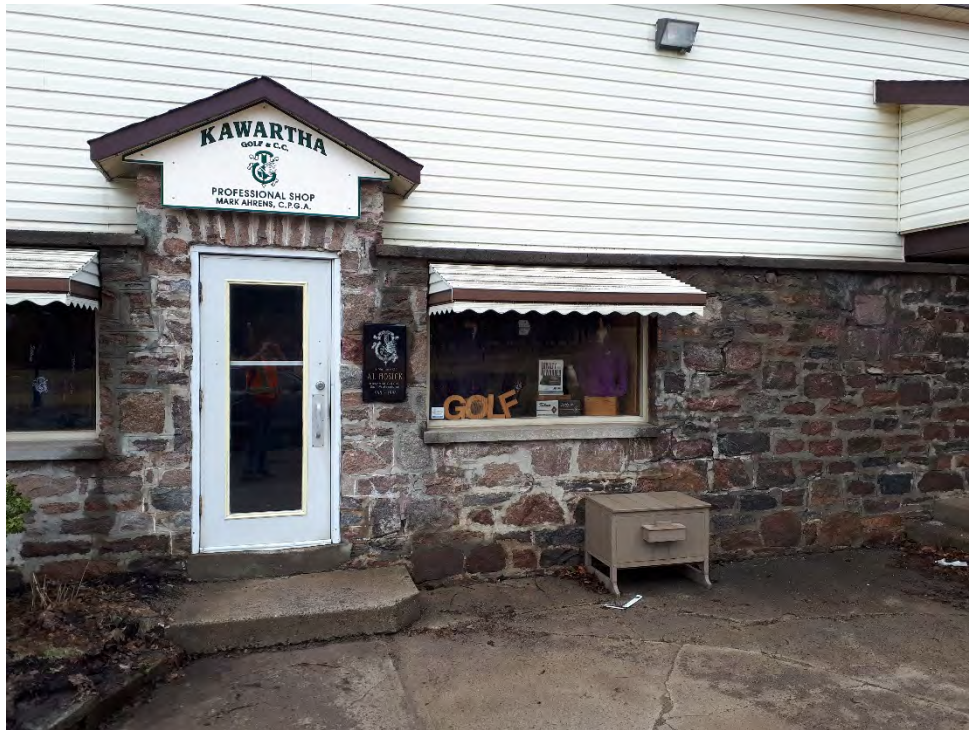
Photo 9 – View of Pro Shop building.

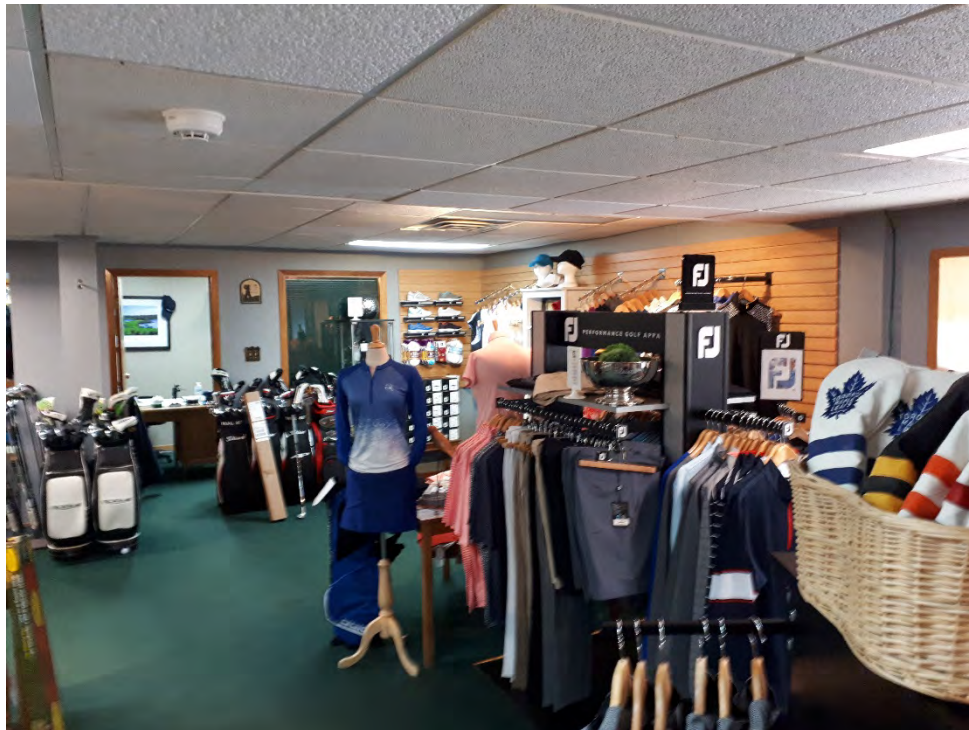
Photo 10 – Finished portion of Pro Shop building.

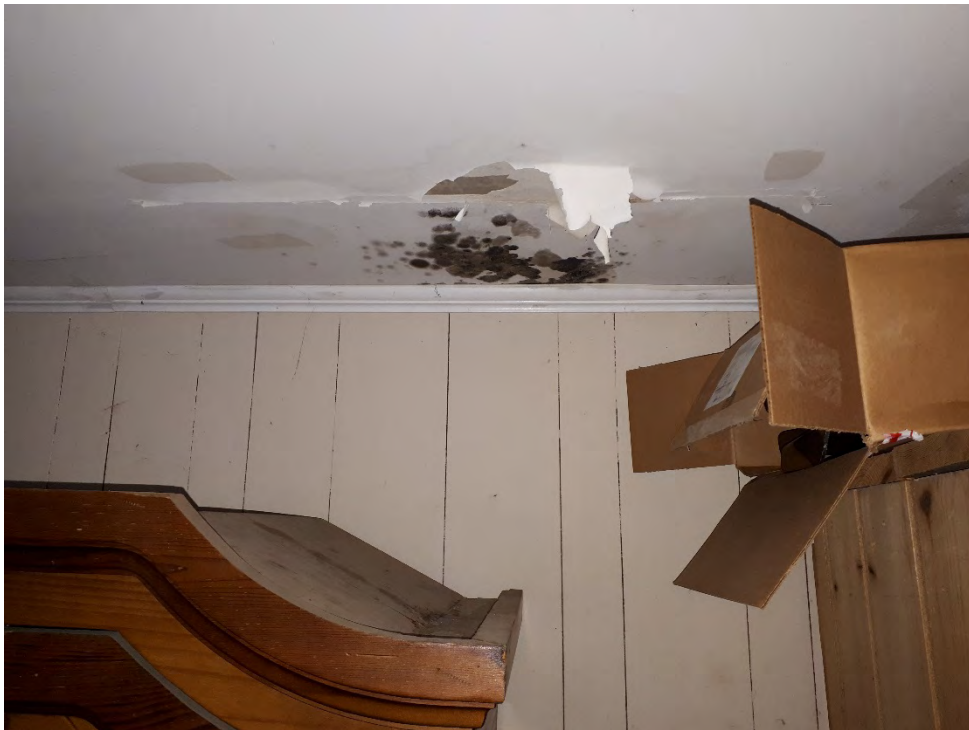
Photo 11 – Mould observed in storage room of Pro Shop. Air sampled in this area (AS-05).

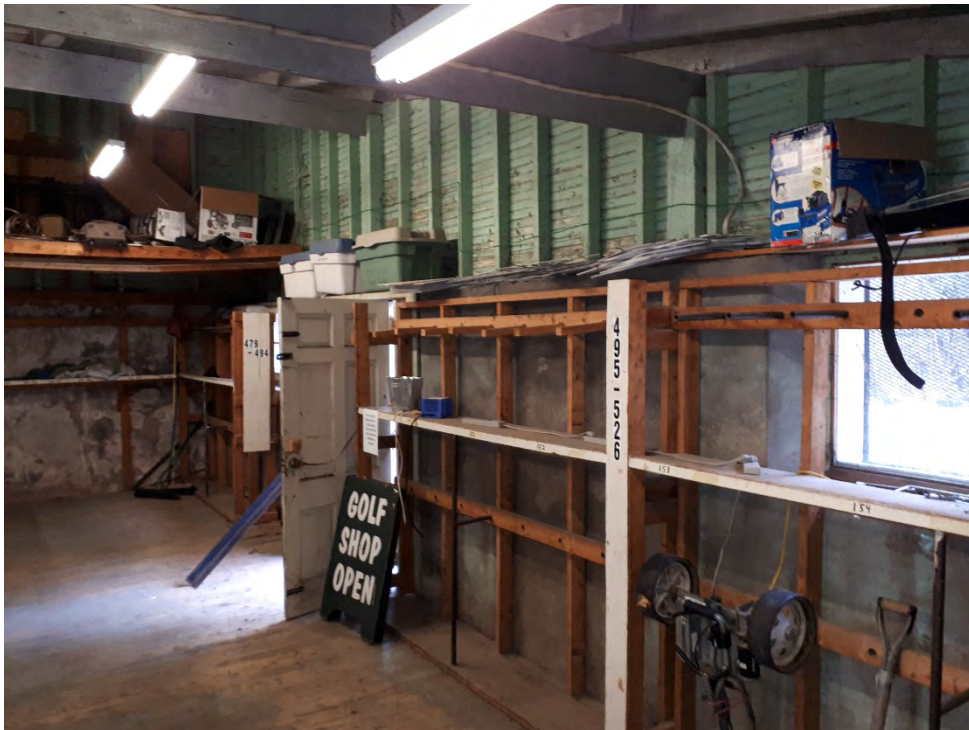
Photo 12 – Green paint in Pro Shop building identified as containing high amounts of lead.
