Designated Substances Survey -8 John Street, Fenelon Falls, Ontario

September 20, 2023

Prepared for:
City of Kawartha Lakes

Cambium Reference: 18639-001

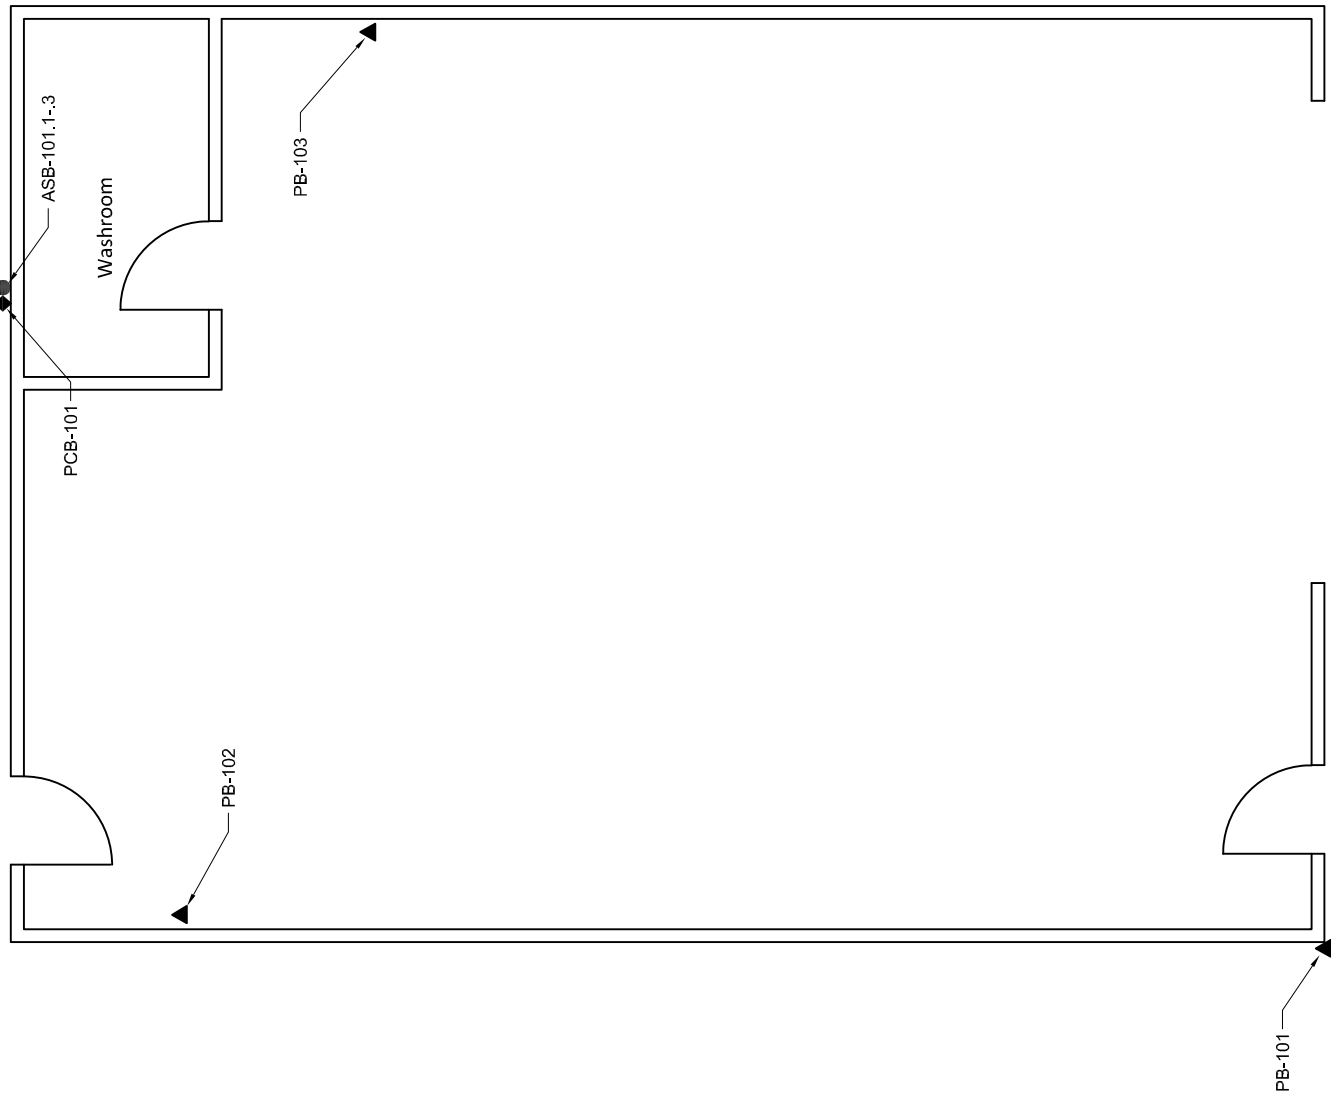
MAIN FLOOR SITE PLAN

Below is a brief summary of building materials identified during the assessment that were suspected of being asbestos-containing. Photographs are included in Appendix A. The laboratory certificate of analysis report for asbestos is included in Appendix B. A drawing showing the locations of all asbestos-containing materials and the locations of samples is present in Figure 1.

The following table summarizes the laboratory results for the bulk samples of paint collected for lead analysis. The laboratory certificate of analysis report for lead is included in Appendix C. A drawing with locations of samples is present in Figure 1.

The following table summarizes the laboratory results for the bulk samples of caulking for PCB analysis. The laboratory certificate of analysis report for PCBs is included in Appendix D. Building layout drawings with the location of the sample is present in Figure 1.

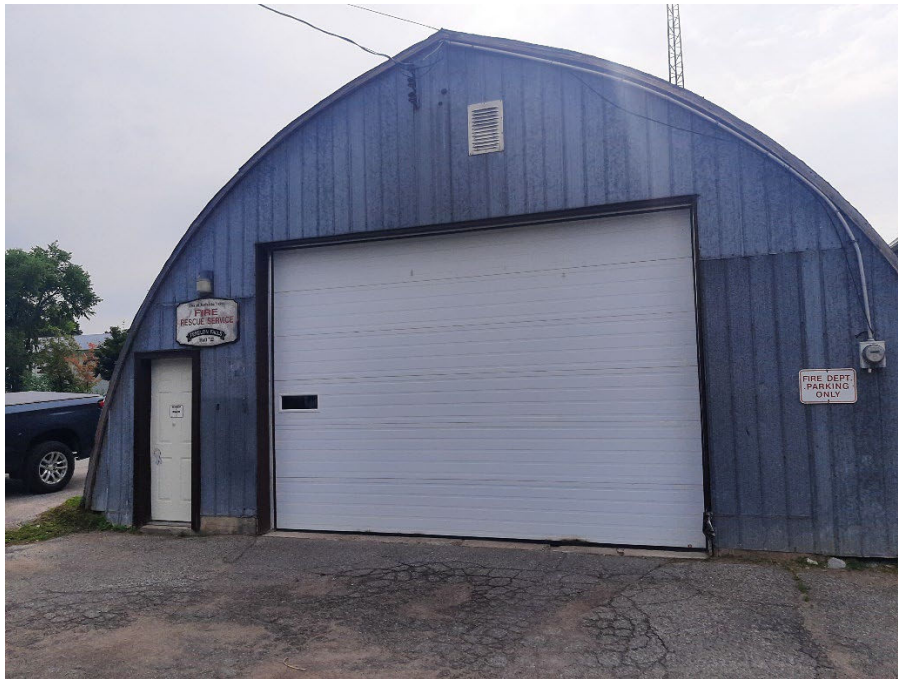
Photo 1 – Exterior view of the building.

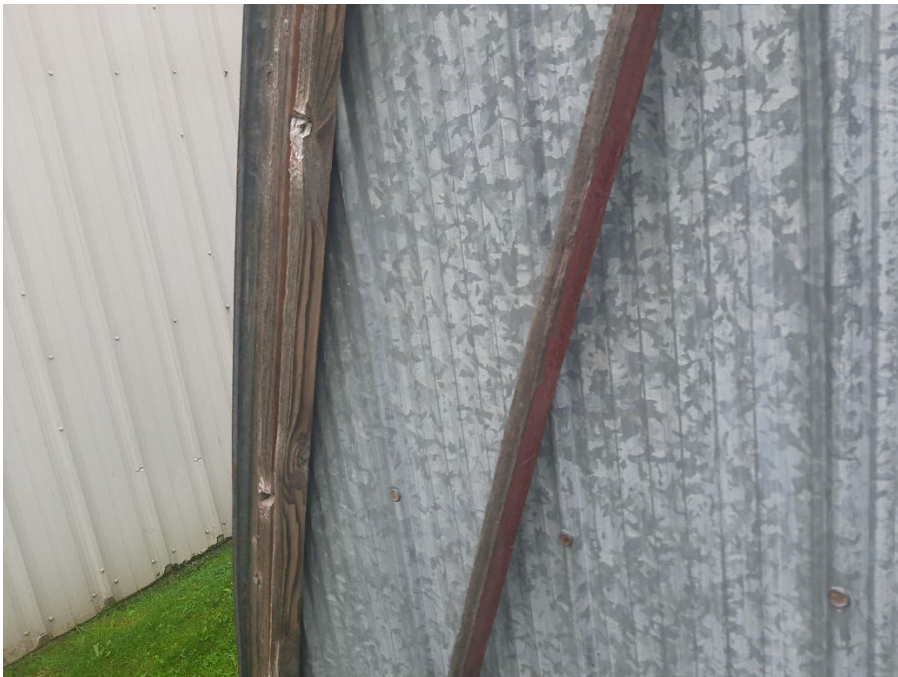
The results of laboratory analysis indicated that red paint on exterior wood trim is lead-based. Yellow paint on the steel gas line is presumed to be lead-based. All remaining painted finishes contain low levels of lead and are not considered to be lead-based. Painted finishes were found to be in good condition.

Photo 2 – Lead-based red paint on exterior wood trim.

- Any paints discovered during the course of renovation activities that are not mentioned in this report shall be considered to be lead-based until sampling and analysis indicates otherwise.
- Red paint on exterior wood trim is lead-based. Remove lead-based painted finishes using Class 1 procedures as outlined in the guideline, “Lead Guideline For Construction, Renovation, Maintenance or Repair” issued by Environmental Abatement Council of Canada, dated October 2014.
- Prior to demolition, leachate samples should be performed on lead-based paints to determine the appropriate waste stream and disposed of in accordance with O. Reg. 347.
- Lead-containing materials (i.e., wiring, piping, etc.) should be recycled.

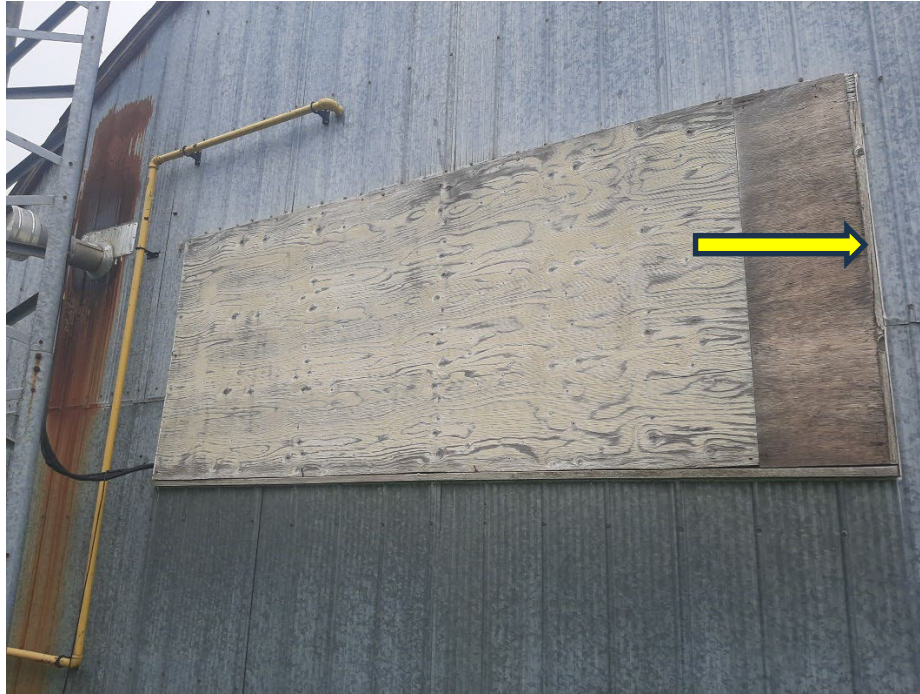
Non-asbestos white caulking is present around exterior doors and seams (samples ASB-101.1 to 101.3).

Photo 3 – Non-asbestos white caulking.
